Drying Potential of Wood Frame Walls Subjected to Accidental Water Infiltration

Marijke Steeman, Nathan Van Den Bossche and Klaas Calle

Building Physics research group, Ghent University, J. Plateauststraat 22 B-9000 Ghent, Belgium,
Marijke.Steeman@UGent.be

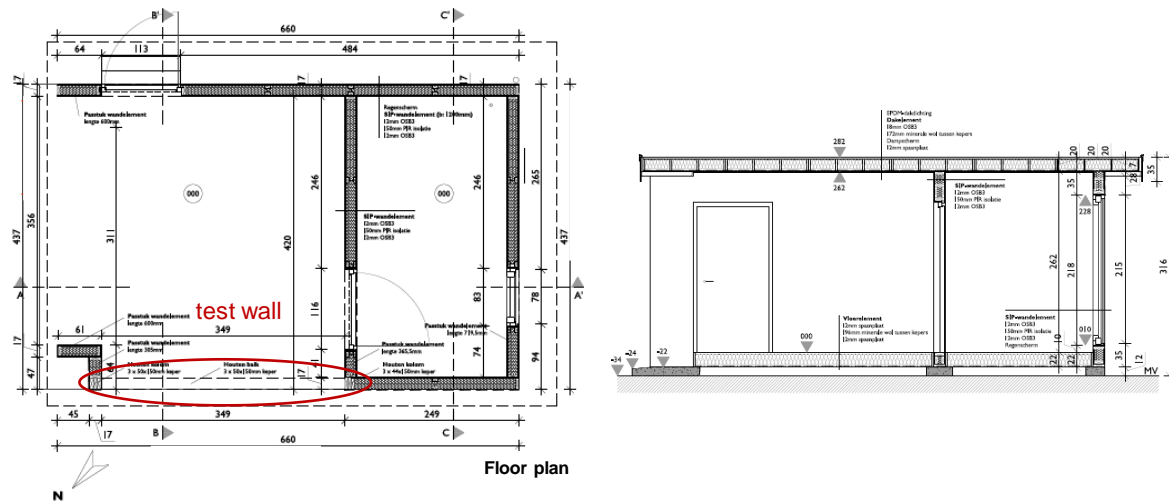
A test pavilion (6,60m x 4,37m) called “STEAMlab21” was built in Kortrijk and consists of two adjacent rooms. Figure 1 shows the floor plan and a vertical section of the pavilion.

Figure 1. Floor plan (left) and section AA' (right).

The exterior north-west facing wall is replaceable and used as a test wall. The test wall is a wood frame wall with 8 compartments. The compartments consist of I-joists filled with insulation material, wood fibre board and a ventilated wooden cladding at the outside. At the inside a service cavity with a gypsum fibreboard finishing is installed. All other exterior walls of the pavilion are constructed with SIP panels.

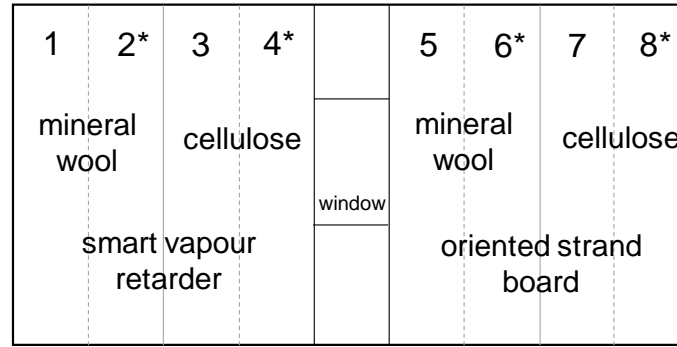
Figure 2. Schematic overview of the test wall with 8 compartments. Compartments with water injection are marked with *.

Each compartment of the test wall measures 34,4 cm width and 266 cm height. The compartments differ in the type of insulation material and the type of vapour retarder that were used. Two types of insulation material were used: mineral wool and cellulose; and two types of vapour retarder: a smart vapour retarder (SVR) and oriented strand board (OSB). In this way 4 types of compartments were obtained, each having a different combination of insulation and vapour retarder. Two identical compartments of each combination of insulation type and vapour retarder were available.

Water is added from the outside in one of the two identical compartments, mimicking rain water infiltration. In order to avoid mutual influence between the compartments, a vapour tight coating was applied to the I-joists between the compartments. Figure 2 lists the characteristics of each wall compartment, while Table 1 shows an overview of the most important material properties. The U-value of the test wall was 0,10 W/m²K for the compartments with mineral wool and 0,11 W/m²K for the compartments with cellulose.

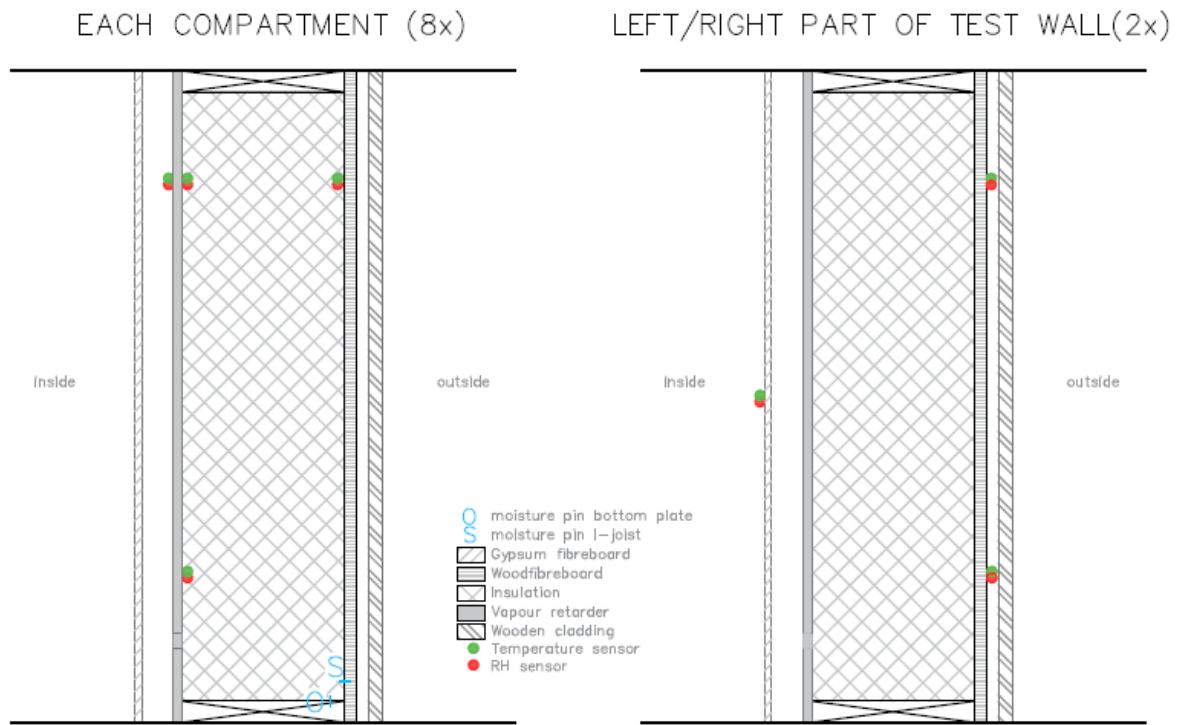
Figure 3. Scheme with location of the sensors in the test wall.

Temperature, relative humidity and moisture content were measured on different locations in the test wall. In total 92 sensors were installed. At the following locations, also indicated in Figure 3, thermocouples type K (accuracy $\pm 0,1^{\circ}\text{C}$) and RH sensors (HIH-40000 Series Humidity Sensors, accuracy $\pm 3,5\%$ RH) were installed:

- On the inner surface of the wall at two locations: in the middle of the left and right wall side, at half height
- In the service cavity of each compartment at $\pm 1,80\text{m}$ height (illustrated in Figure 4, left photo)
- On the interior side of the insulation layer for each compartment, at two heights: at $\pm 0,80\text{m}$ and at $\pm 1,80\text{ m}$ height
- On the exterior side of the insulation layer for each compartment, at $\pm 1,80\text{ m}$ height
- In the ventilated cavity of the wall at two locations: in the middle of the left and right wall side, at $\pm 0,80\text{m}$ and at $\pm 1,80\text{ m}$ height (illustrated in Figure 4, photo on the right)

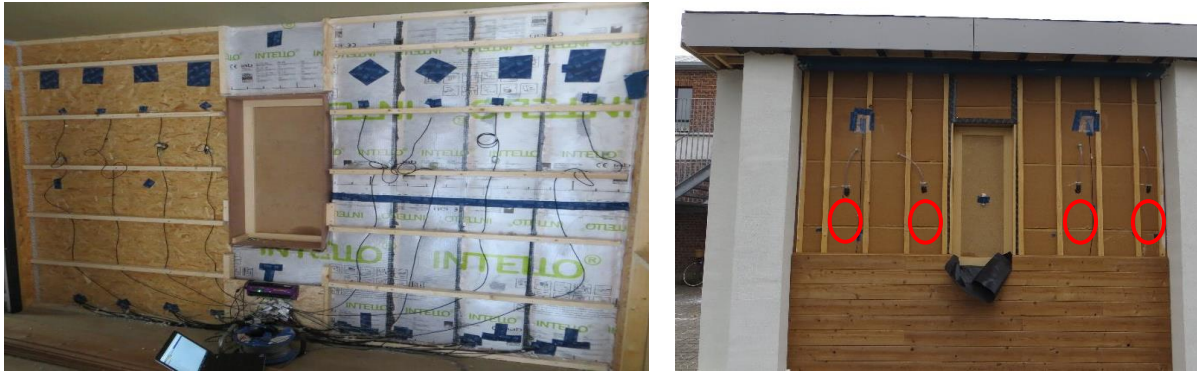
Figure 4. View on the compartments from the inside (photo left) and view on the outside with water infiltration tubes, indicated with a red circle (photo right).

In 4 compartments (2, 4, 6 and 8) 0,2323 l water was injected into the insulation layer. Figure 4 (photo on the right) shows the outside of the test wall with the infiltration tubes at half height. The tubes were installed in such a way that the water infiltrates between the wood fibre board and the insulation layer.

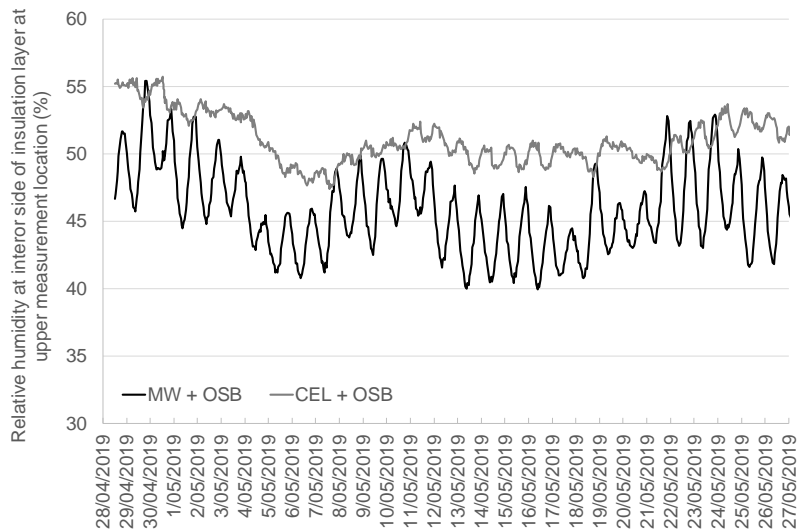
Figure 5 shows the course of the relative humidity in the insulation layer for a compartment filled with mineral wool (compartment 5) and a compartment filled with cellulose insulation (compartment 7). In both compartments, there was no water infiltration.

Figure 5. Course of the RH measured at the inside of the insulation layer (upper measurement location) for a compartment with mineral wool (comp. 5) and cellulose (comp. 7), both without water infiltration.

Figure 5 shows that the relative humidity fluctuates a lot more in the compartments filled with mineral wool compared to the compartments filled with cellulose insulation. This observation is expected and can be explained by the hygroscopic characteristics of cellulose. The oriented strand board has similar moisture buffering characteristics, but because the

thickness of the layer is limited (0,015m), this effect is rather small.

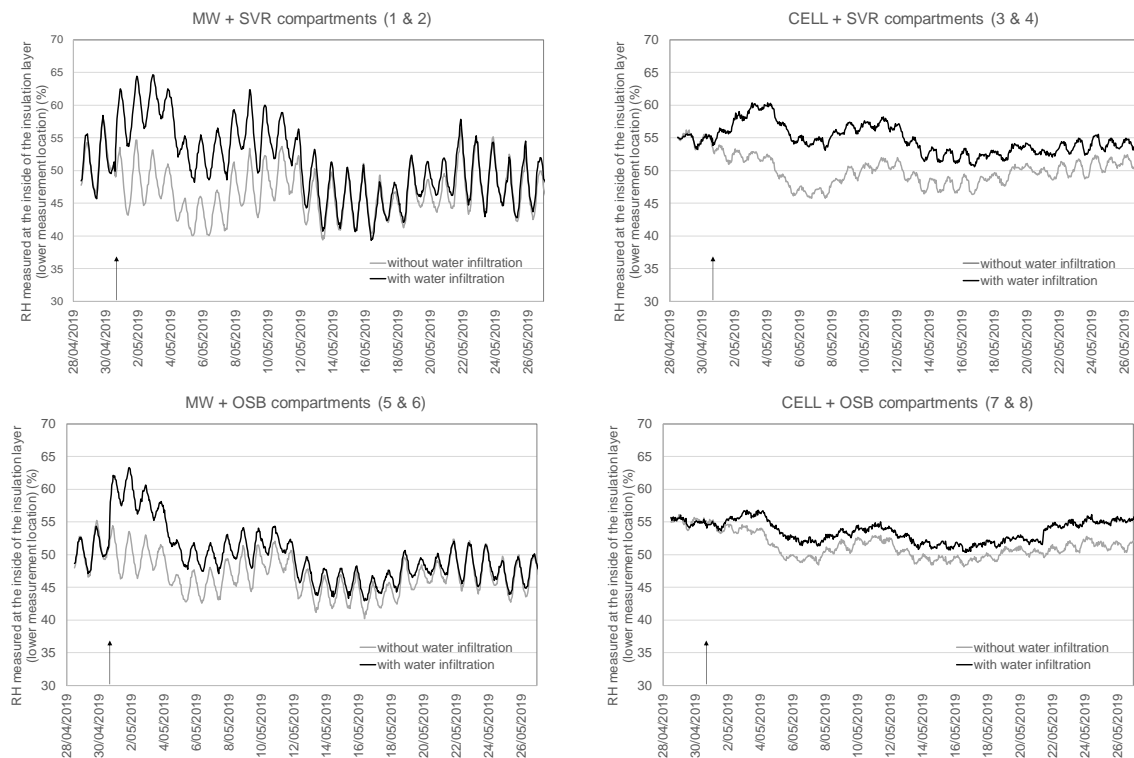
Figure 6 compares the relative humidity of the wall compartments with and without water infiltration for each combination of insulation and vapour retarder. The moment water is injected into the construction can be clearly read from the graphs (also indicated with a black arrow). The graphs show that the relative humidity increase is higher for the compartments with mineral wool than for the compartments with cellulose insulation. This can again be attributed to the hygroscopic characteristics of cellulose.

Figure 6. Course of the RH measured at the inside of the insulation layer (lower measurement location) for all compartments, with and without water infiltration.

When the measurement results were analyzed it was clear that the injection of water was mainly visible at the interior side of the insulation (lower measurement location). The relative humidity clearly increases when water is injected.

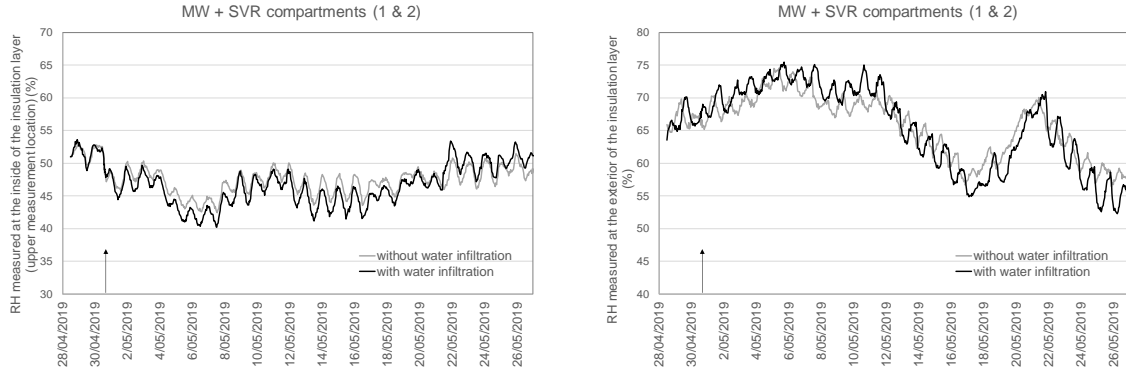
Figures 7 and 8 show the relative humidity course measured at the interior side of the insulation (upper measurement location) and at the exterior side of the insulation for compartments 1 and 2, and 3 and 4 respectively. It is clear that the water injection is harder to observe from these measurement locations. For the compartments with mineral wool (Fig. 7) the relative humidity of the dry compartment is slightly higher than the relative humidity of the wet compartment, although the difference is still within the accuracy of the sensor. For the compartments with cellulose insulation (Fig. 8) the relative humidity of the wet compartment is slightly higher than the relative humidity of the dry compartment, but the difference is very

Figure 7. Course of the RH measured at the inside of the insulation layer (upper measurement location) (left) and at the exterior side of the insulation layer (right) for the compartments with mineral wool and SVR (1 & 2).

limited. For the other compartments, similar observations were made. This suggests that the injected water mainly runs down at the interior side of the insulation layer, especially for the compartments with mineral wool because the moisture buffering capacity of mineral wool is very low.

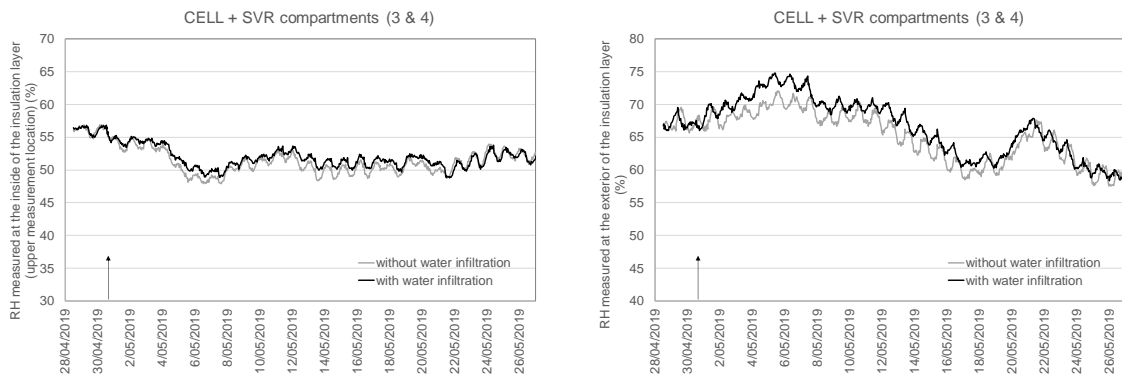
Figure 8. Course of the RH measured at the inside of the insulation layer (upper measurement location) (left) and at the exterior side of the insulation layer (right) for the compartments with cellulose and SVR (3 & 4).

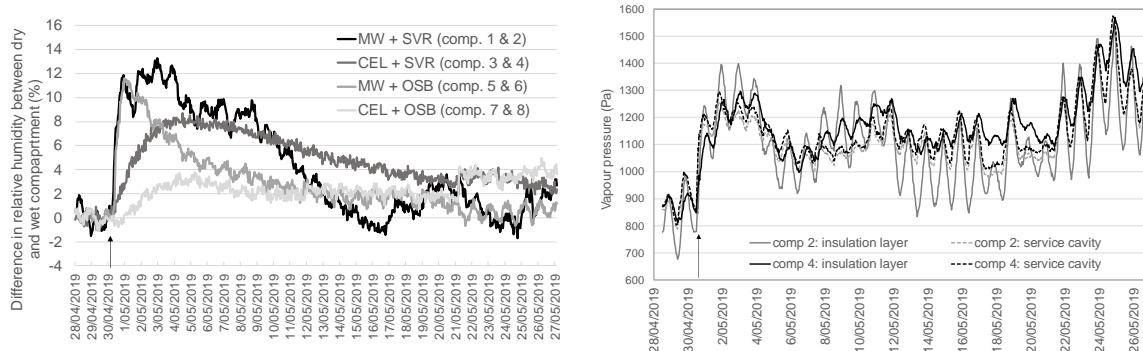
In order to estimate the drying rate of the test compartments, the relative humidity of the wet and dry compartment of each construction type are compared (lower measurement location at interior side of insulation) in Figure 9 (graph left). The relative humidity difference increases faster in the compartments filled with mineral wool compared to the compartments filled with cellulose. Similarly, the drying rate of the compartments with cellulose is lower.

Figure 9. Difference in RH between wet compartment and the dry compartment (left) and vapour pressure in the insulation layer and service cavity for compartments 2 (MW + SVR) and 4 (CELL + SVR).

For the compartment with mineral wool and SVR (compartment 2) and with mineral wool and OSB (compartment 6), the drying period is ± 14 days and ± 21 days respectively. For the compartments with cellulose (compartments 4 and 8), the drying period is considered longer then the measurement period (> 27 days). For compartment 8 an increase in RH is noted after 21 days (May 21th), but no explanation for this observation could be found.

Drying out is considered mainly towards the inside of the construction. Figure 9 (right-hand graph) compares the measured vapour pressure in the insulation layer (interior side, lower measurement location) with the vapour pressure in the service cavity. For compartment 2 with mineral wool drying starts immediately after water infiltration, while for compartment 4 with

cellulose there is a time delay and drying starts later. During measuring, there were no internal moisture loads.
